An Assessment of the Performance of Raccoon Island Breakwater Projects

Glen Curole
CPRA-Coastal Resources Scientist

3rd Biennial State of Coast Conference
March 18-20, 2014
Ernest N. Morial Convention Center
New Orleans, LA

RACCOON ISLAND BREAKWATER PROJECTS

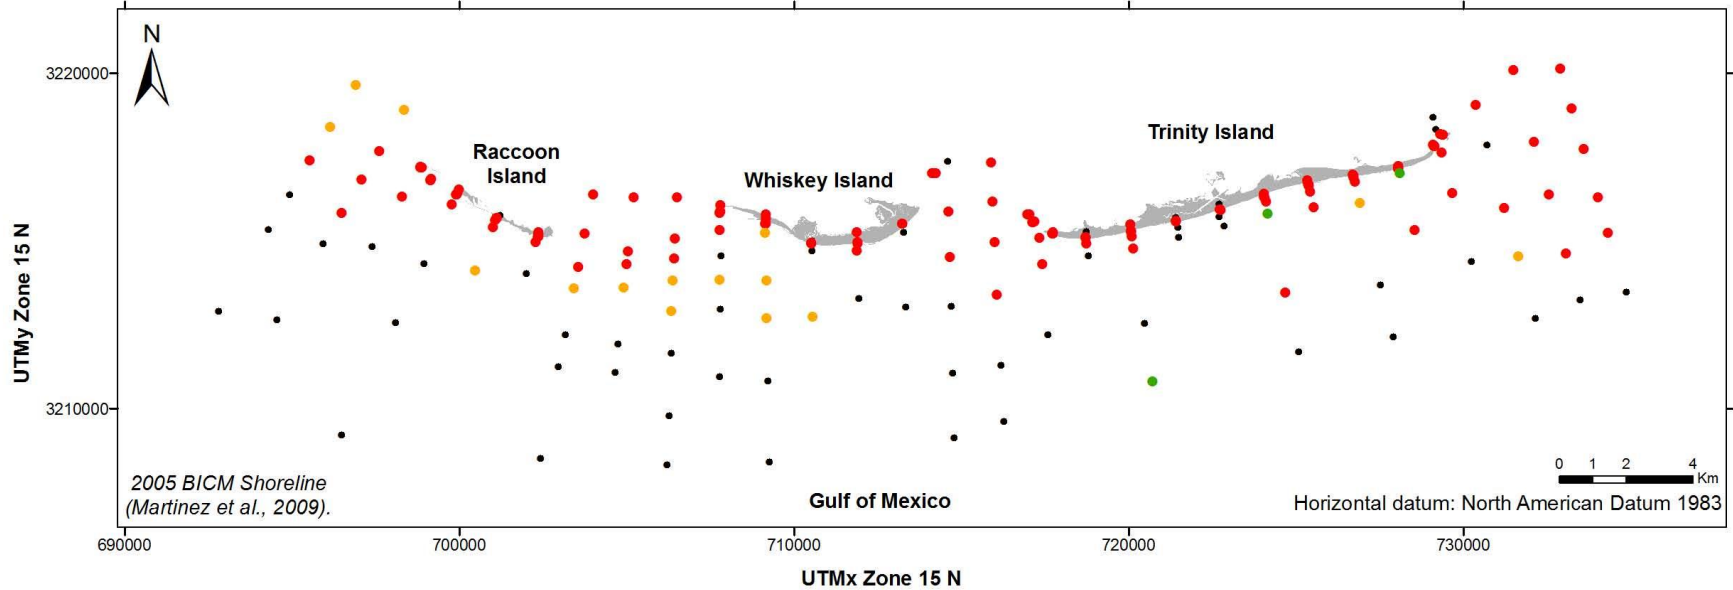
Teche Region- 2008 - Percent Composition Sand

Indicated by Particle Size Analysis

Grain Size Analysis

Samples from this location were taken by surface scooping on land and by bottom grab sampling in the water. They were then analyzed visually for percent composition of sand.

Samples that were estimated to be greater than 70 percent sand were quantitatively described using laser particle size diffraction methods.

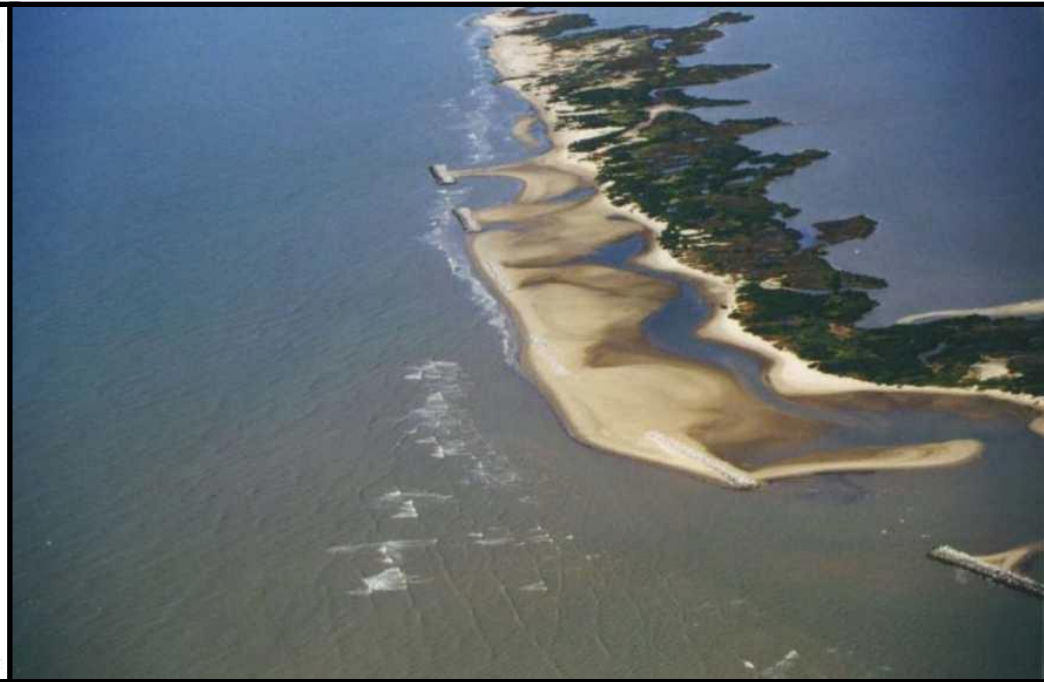
February 1998

1998 DOQQ
2001 Aerial Imagery

- Successful in Increasing Sediment Volume due to Nearby Sand Shoal
- Deep Channel Formed in Lee of Breakwaters #0 and #1
- Down Drift Impacts to the West

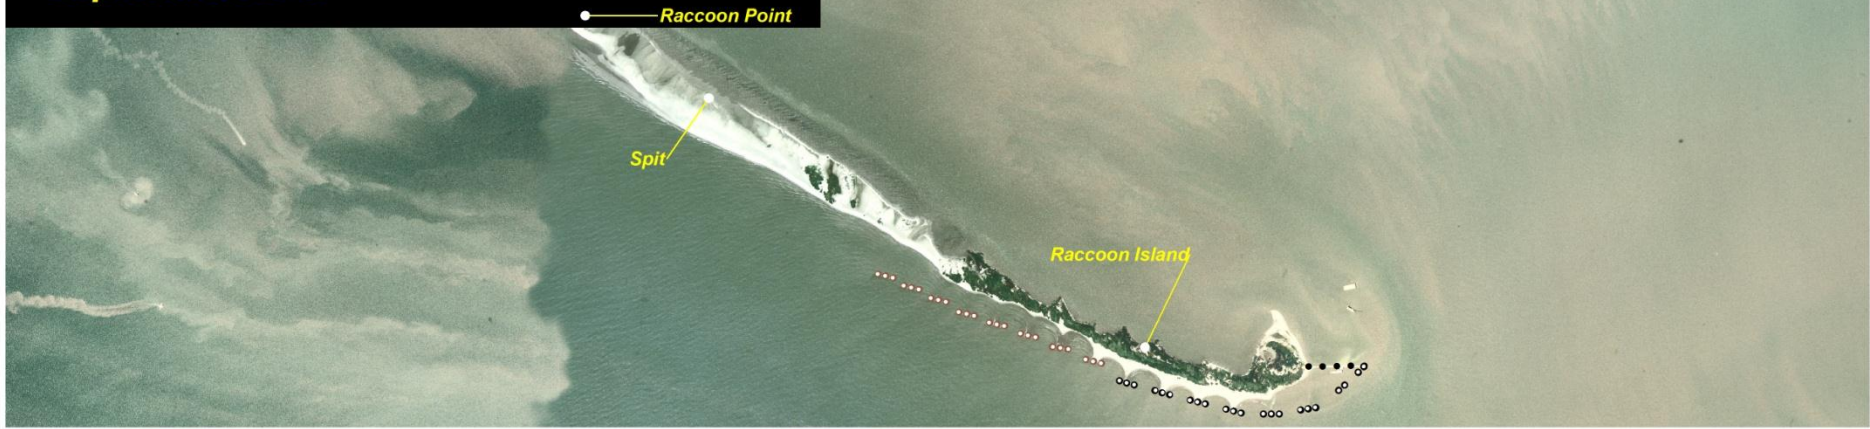
September 2007

○○○○○○○○	TE-29 Breakwaters
○○○○○○○○	TE-48 Breakwaters
●●●●●●	TE-48 Groin

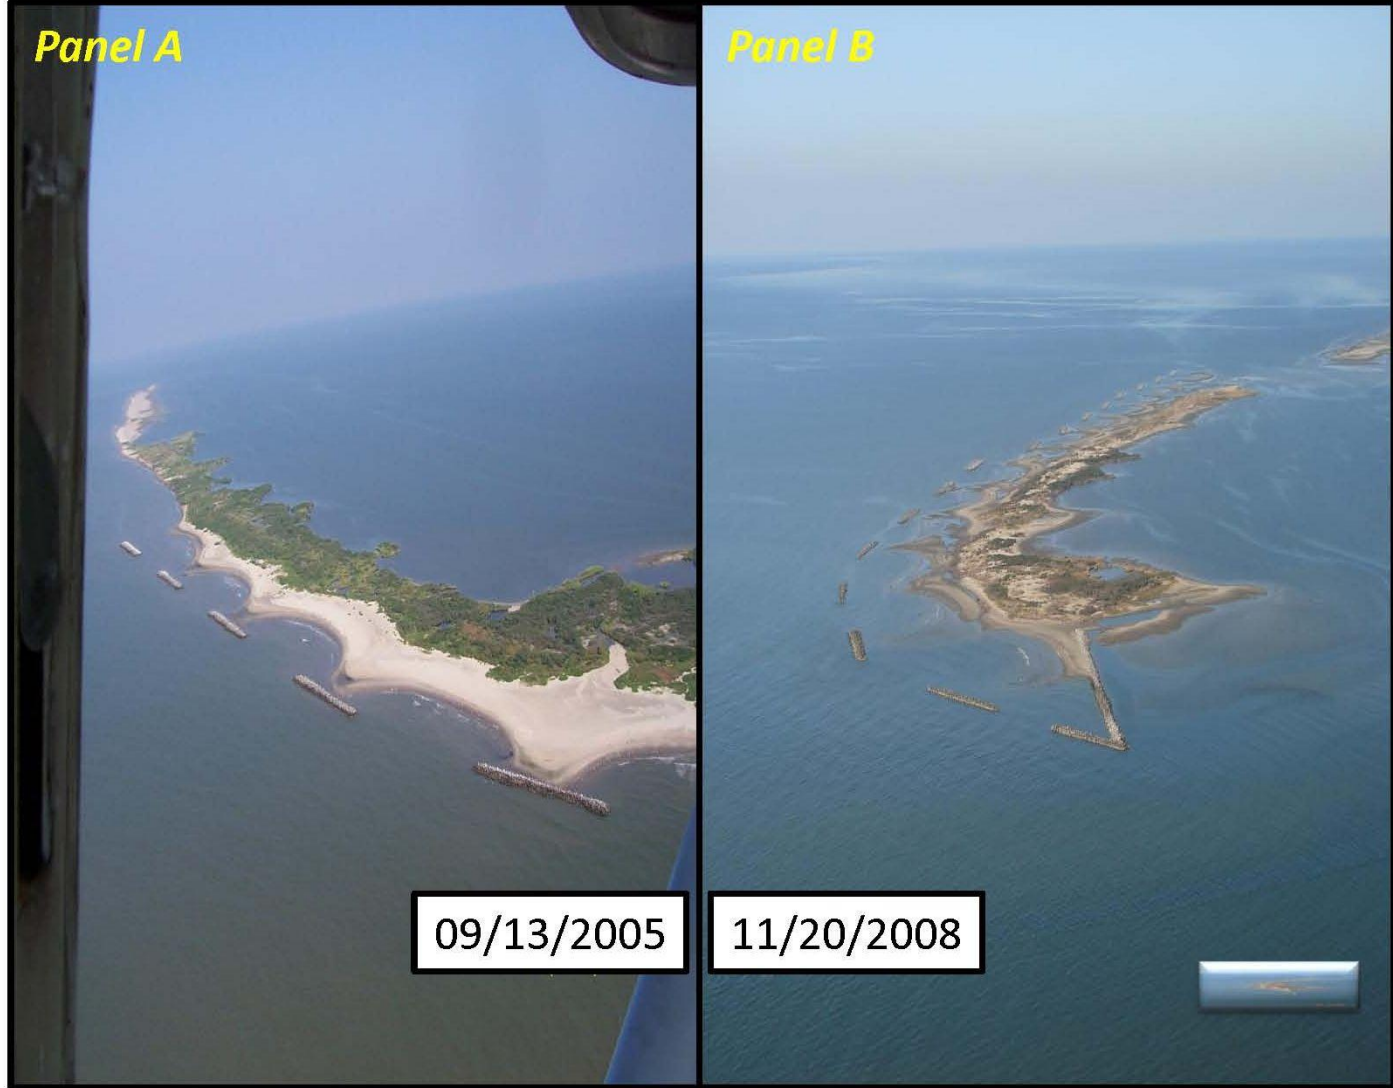
Panel A

09/13/2005

11/20/2008

2008 DOQQ

Grid Statistics ft (m)
Cell Size: 3.28 (1.00)
Maximum: 7.25 (2.21)
Minimum: -9.81 (-2.99)
Standard Deviation: 1.77 (0.54)
Mean: -0.36 (-0.11)

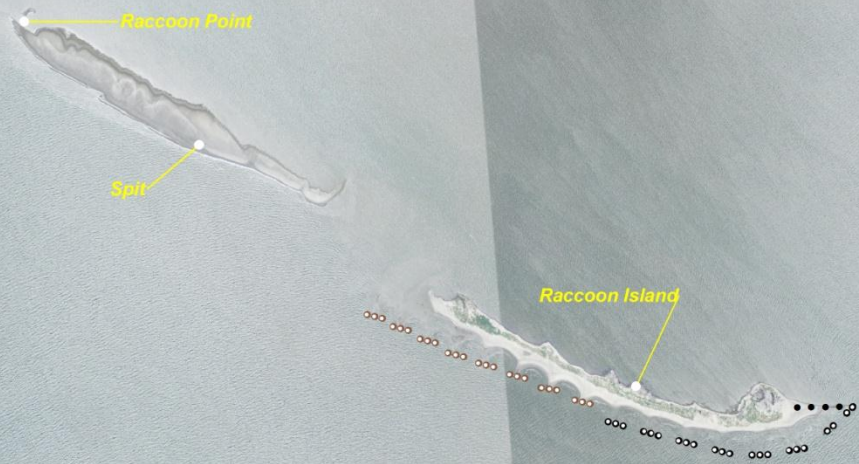
July 2010

- TE-29 Breakwaters
- TE-48 Breakwaters
- TE-48 Groin

- TE-48 Breakwaters have Raised Shoreline Contours in Their lee
- Groin has Increased Volumes and Extended Shoreline Positions
- Raccoon Island Spit has Recorded Sediment Deficits Since TE-48 Construction
- TE-29 Breakwaters #3-#6 have Recorded Sediment Deficits Since TE-48 Construction
- Raccoon Island Substantially Impacted by Tropical Storms During Study
- Recommend Comprehensive Sediment Budget Study
- Recommend Closing Breach and Reconnecting Spit
- Recommend Creating Marsh Behind Spit to Increase Width
- Recommend Beach Nourishment Event
- Recommend Western Terminal Groin

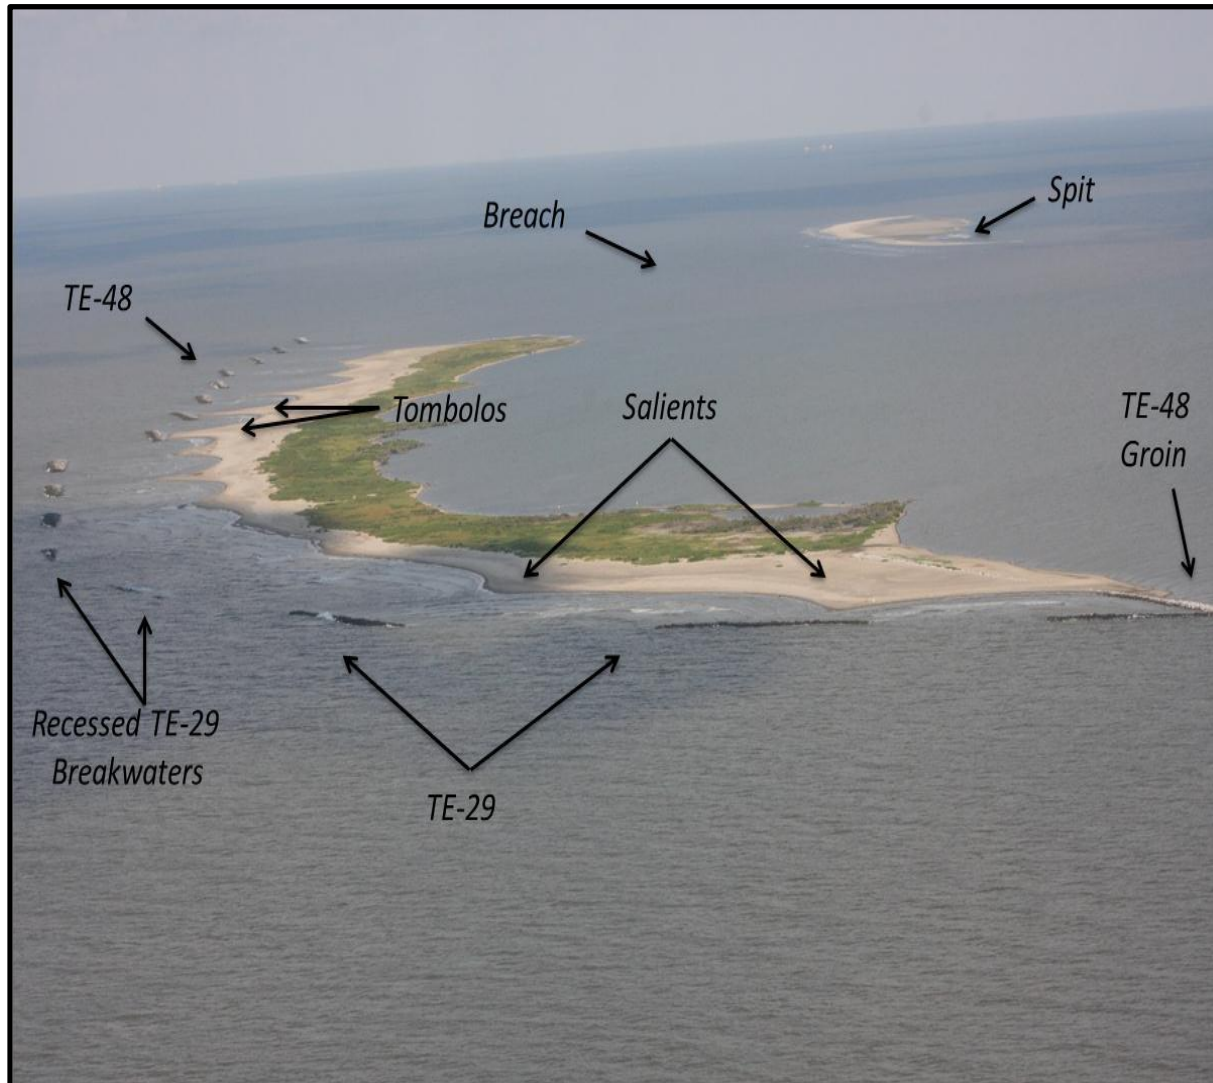
Post Hurricane Isaac Oblique Aerial Photograph of Raccoon Island (Sep 2012)

ESTIMATED BREACH FILL VOLUMES & DEPTHS

Fill Elevation	Fill Volume	Fill Depth
NAVD88 ft	yd ³	ft
0.00	476,808	2.36
1.00	678,710	3.36
1.54	786,693	3.90
2.00	880,612	4.36
2.50	981,583	4.86
3.00	1,082,514	5.36
