# QUEEN BESS ISLAND RESTORATION

## BACKGROUND

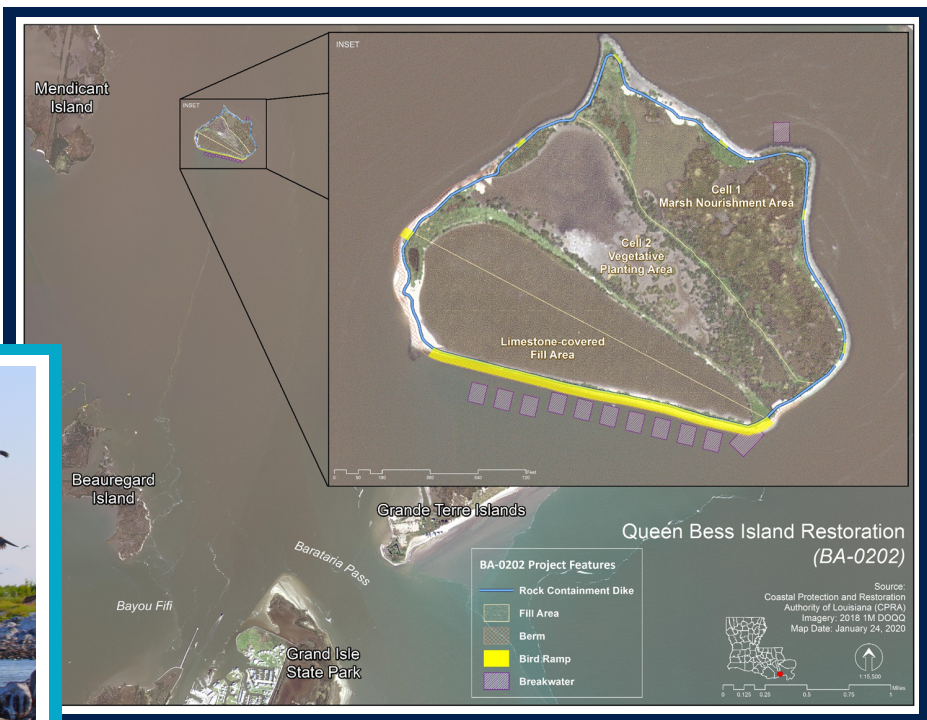
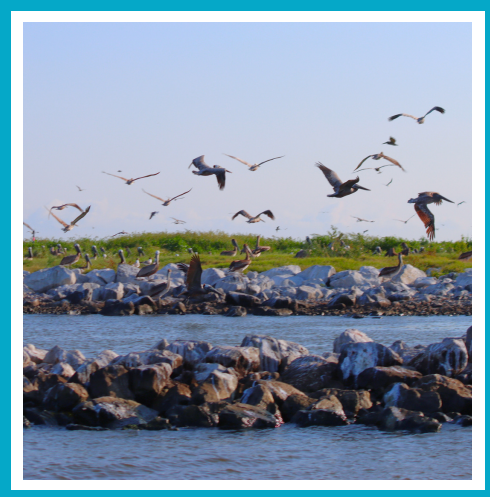
This project map shows the three designed fill cells. In yellow are the bird ramps that provide access to shallow waters for smaller birds, in the purple are breakwaters designed to protect the tidal exchange point in the north and provide calm waters for swimming and fledging in the south, and in blue is the rock containment dike meant to contain fill material and further protect the nesting grounds. The limestone covering the sand fill in Cell 3 was intended to reduce vegetation growth, addressing an important nesting preference for terns and Black Skimmers. The rest of the island supports the nesting preferences of other colonial waterbirds, like Brown Pelicans, herons, and egrets.
