# QUEEN BESS ISLAND RESTORATION

## BACKGROUND

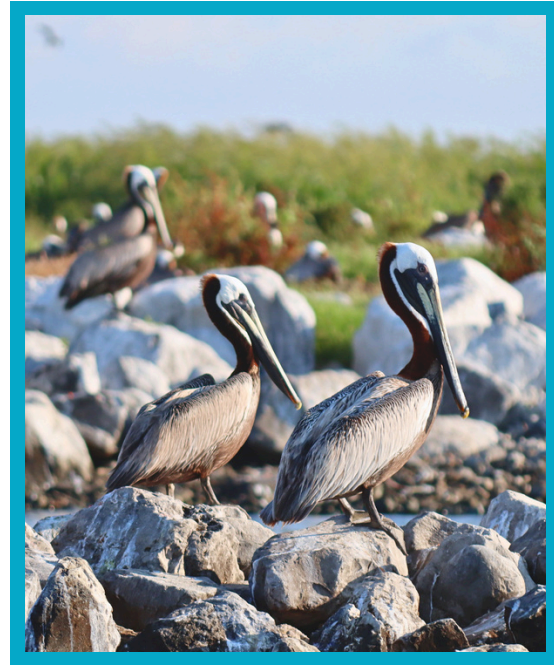
The perimeter of the island is protected by a rock dike originally constructed during a previous project. The existing footprint has survived the major hurricanes of the 21st Century.

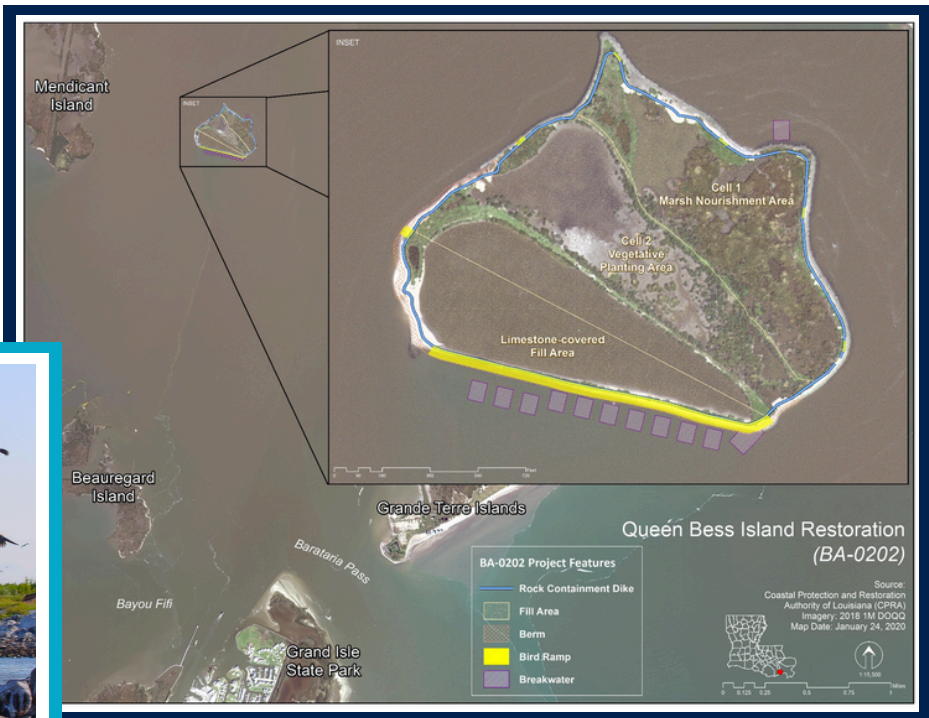
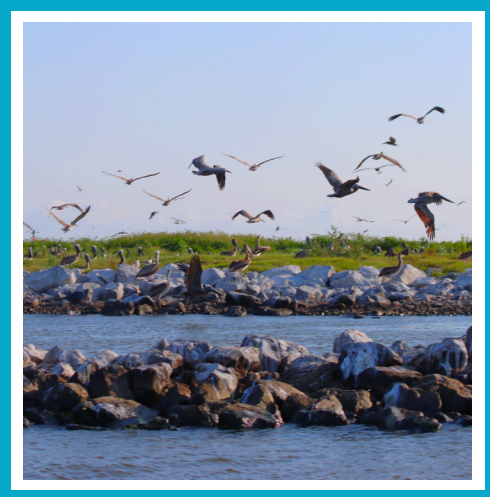
This project map shows the three designed fill cells. In yellow are the bird ramps that provide access to shallow waters for smaller birds, in the purple are breakwaters designed to protect the tidal exchange point in the north and provide calm waters for swimming and fledging in the south, and in blue is the rock containment dike meant to contain fill material and further protect the nesting grounds. The limestone covering the sand fill in Cell 3 was intended to reduce vegetation growth, addressing an important nesting preference for terns and Black Skimmers. The rest of the island supports the nesting preferences of other colonial waterbirds, like Brown Pelicans, herons, and egrets.

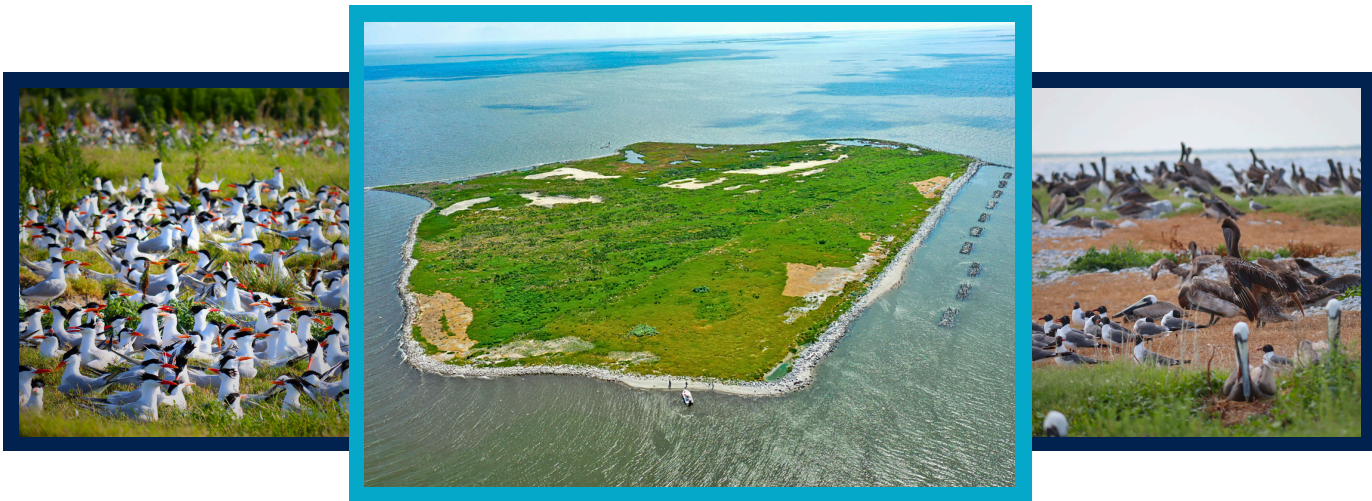
The existing rock ring around the island was enhanced to serve as containment for the ~150,000 cubic yards of Mississippi River sand fill material that were procured from a sand pit and then barged to the project site. Similar fill materials used in previous projects have provided a good combination of stability and ability to sustain vegetation. The island's elevation is highest on its southwestern side, approximately four feet above sea level after construction. The elevation gradually slopes downward toward the northeast side of the island, where intertidal marsh elevations and an enhanced tidal exchange gap support the growth of black mangroves and essential fish habitat. A nearby breakwater reduces wave-driven erosion through the tidal gap. In the middle elevations, scrub-shrub vegetation was planted to support Brown Pelican and colonial wading bird nesting.

The southwestern third of the island, approximately seven acres, was designed as tern and Black Skimmer habitat. Six inches of small limestone were placed on top of the sand fill there to inhibit vegetation growth, enhancing the attractiveness to these bare-ground-nesting birds. Segmented breakwaters were installed on the island's southwest side to dissipate wave energy, providing young birds with a calm water environment for swimming and fledging. Bird ramps were created with medium-sized stone in sections of the rock dike that might be difficult for flightless juvenile birds to safely traverse to gain access to the water.

Engineers estimate that the fill material will settle significantly within the first five years after construction. An additional six inches of small limestone is scheduled to be installed in the tern and Black Skimmer habitat in the fifth year, which engineers estimate will keep that area from settling below the mean high water level for at least the rest of the project's 20-year design life. By the end of the first decade after construction, the middle elevations are expected to settle to intertidal levels. The scrub-shrub vegetation there should support nesting well into the future.
